# Design Access Statement for

## Roof refurbishment, Christchurch Studios, 38 Portland Street, Clifton, Bristol

Prepared on behalf of : Bristol Old Vic Theatre School

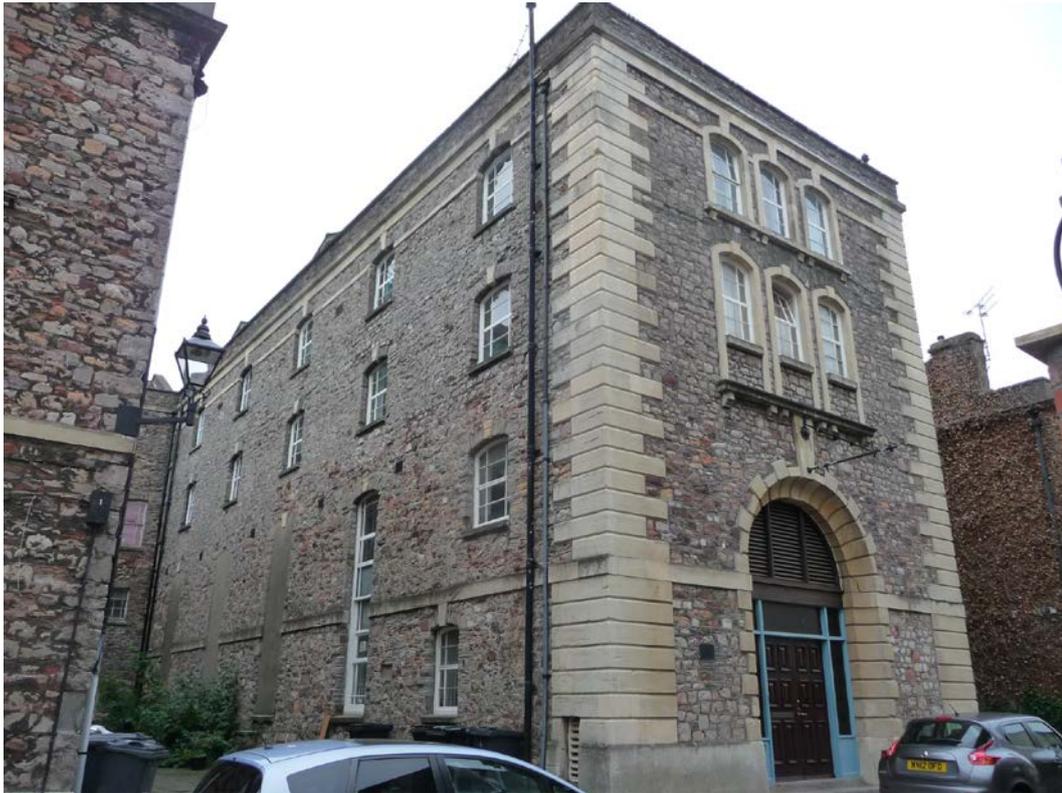
**Photograph 1:** Front and left hand (south and west) elevations, facing Portland Street.

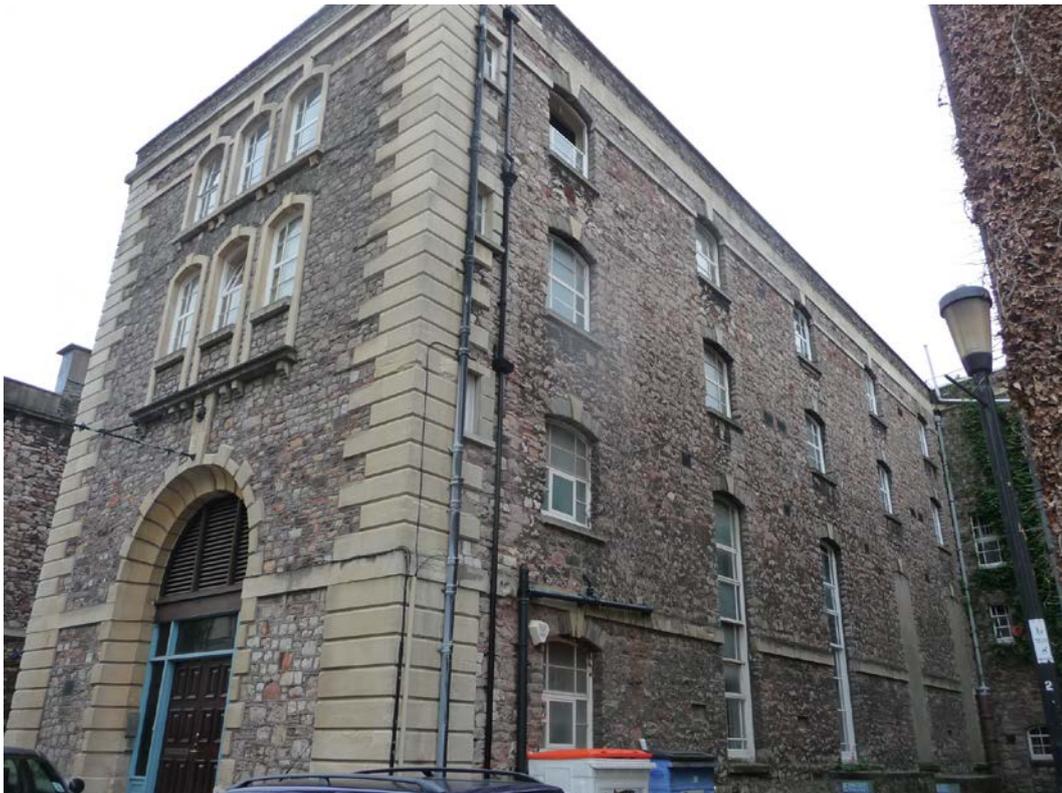
**Photograph 2:** Front and right hand (south and east) elevations, facing Portland Street.

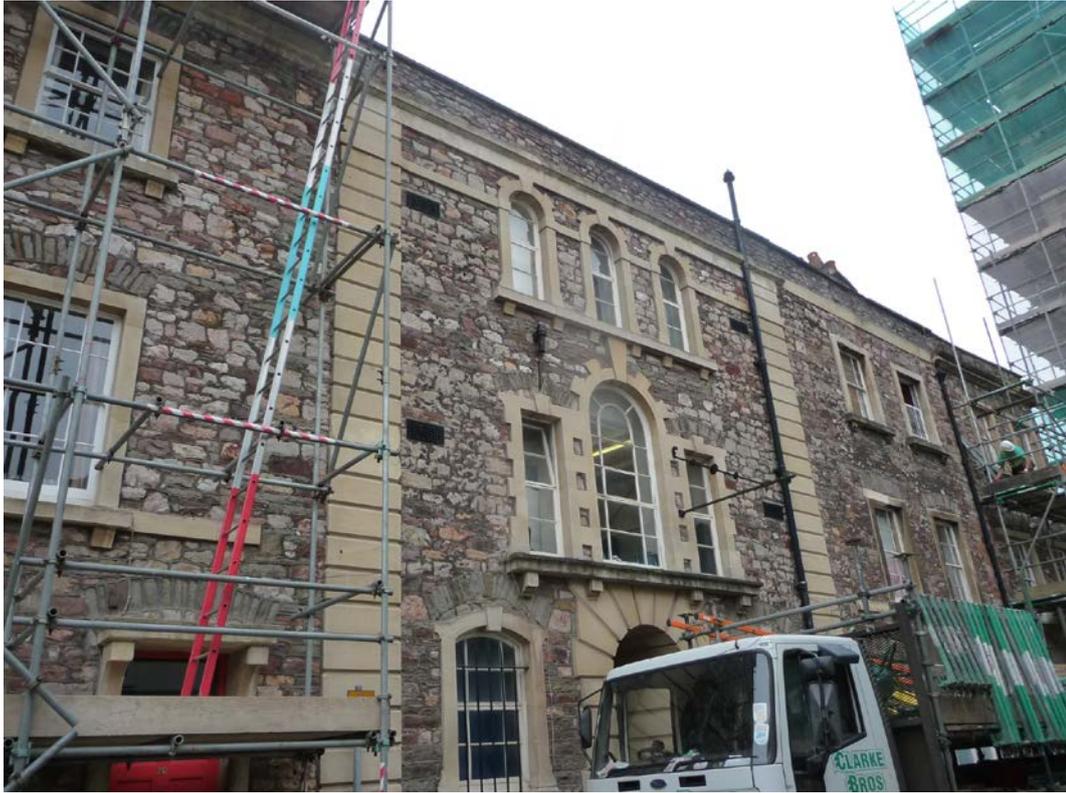
**Photograph 3:** Rear elevation facing Gloucester Street.

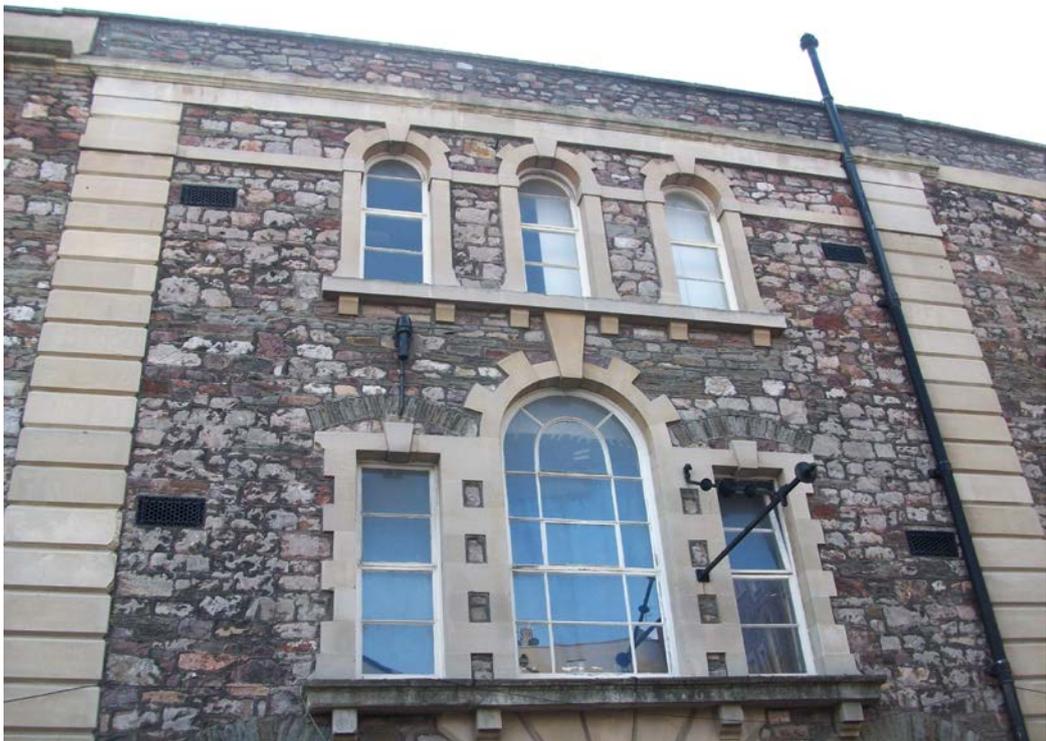
**Photograph 4:** Rear elevation at high level.

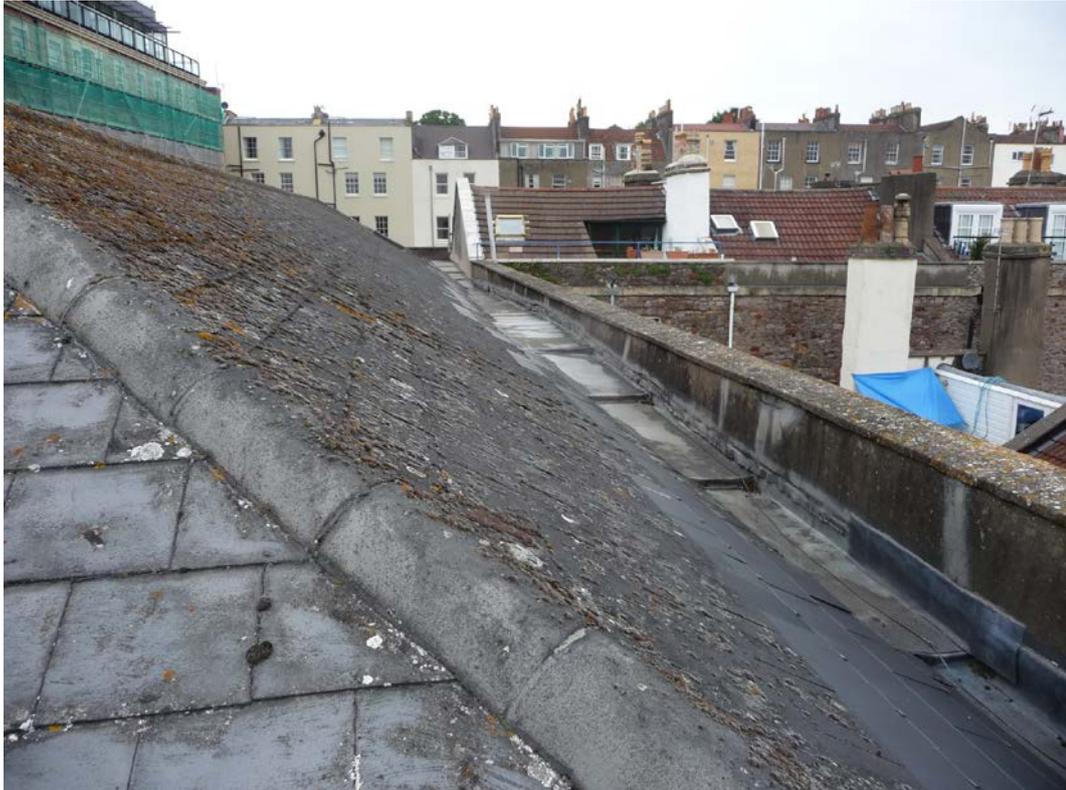
The property is of solid masonry construction with a traditional pitched cut timber framed roof. The roof is covered with bituminous felt and asbestos cement slates. However, the roof has been patch repaired numerous times in response to reactive maintenance and leaks. The covering comprises a number of different types and quality of cement fibre slate, which are poorly fixed and unsafe. The existing bituminous sarking felt beneath is very brittle with numerous holes and tears. The existing zinc-lined parapet gutters have been inappropriately patch repaired with bitumen felt, again as a short-term, reactive measure only. Furthermore the back face of the

**Photograph 5:** Existing roof covering facing north (from south east corner).

- Stripping existing roof coverings including existing asbestos cement slates, battens and sarking felt.
- A short section of decayed timber to the wall plate will be renewed on a like-for-like basis in terms of timber species, size and profile. The new section will be approximately 3m in length. Should it become apparent that further repairs are required, these will be undertaken in the same manor.
- Triso-Super 10+ 38mm multilayer insulation will be stapled over the top of the existing rafters. 38mm x 25mm counter battens will be positioned over the insulation and nail fixed to the rafters below, covered with a Web UV25 breathable membrane, 38mm x 25mm tile battens and Marley Eternit Rivendale fibre cement slates, installed in accordance with the manufacturers recommendations.
- Water damaged sections of lath and plaster ceiling will be repaired on a like-for-like basis.

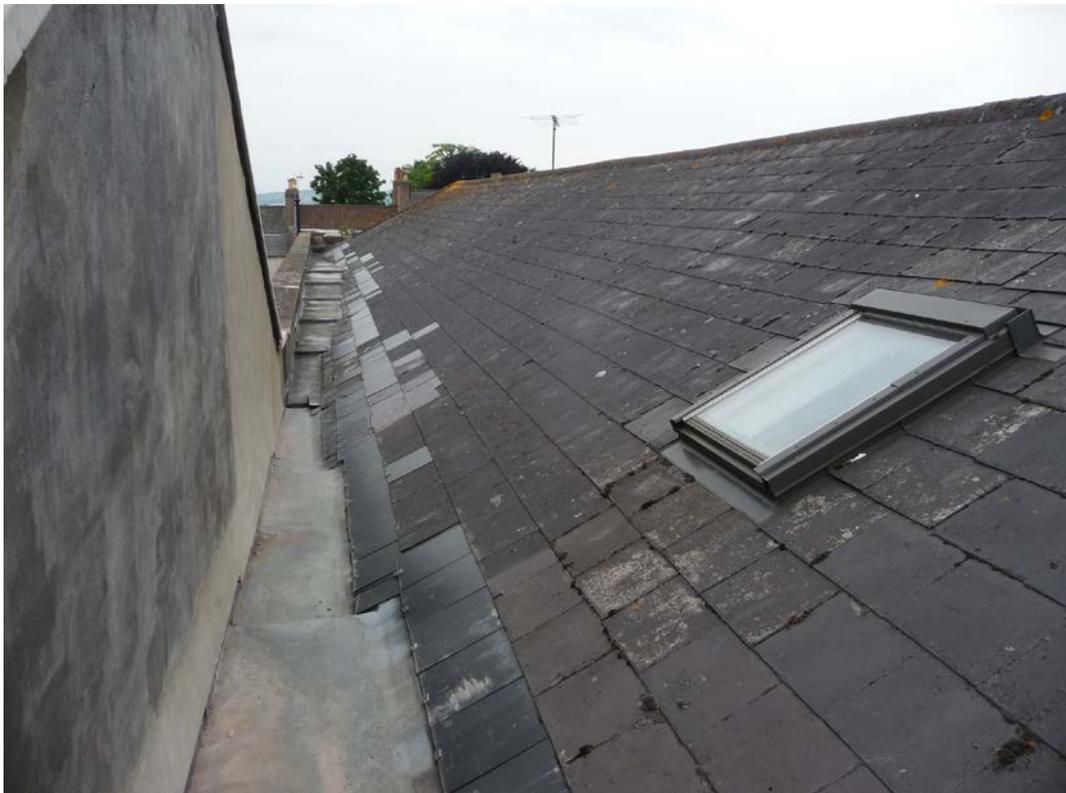
**Photograph 6:** Existing roof covering and parapet gutter adjacent to 10 Gloucester Street.

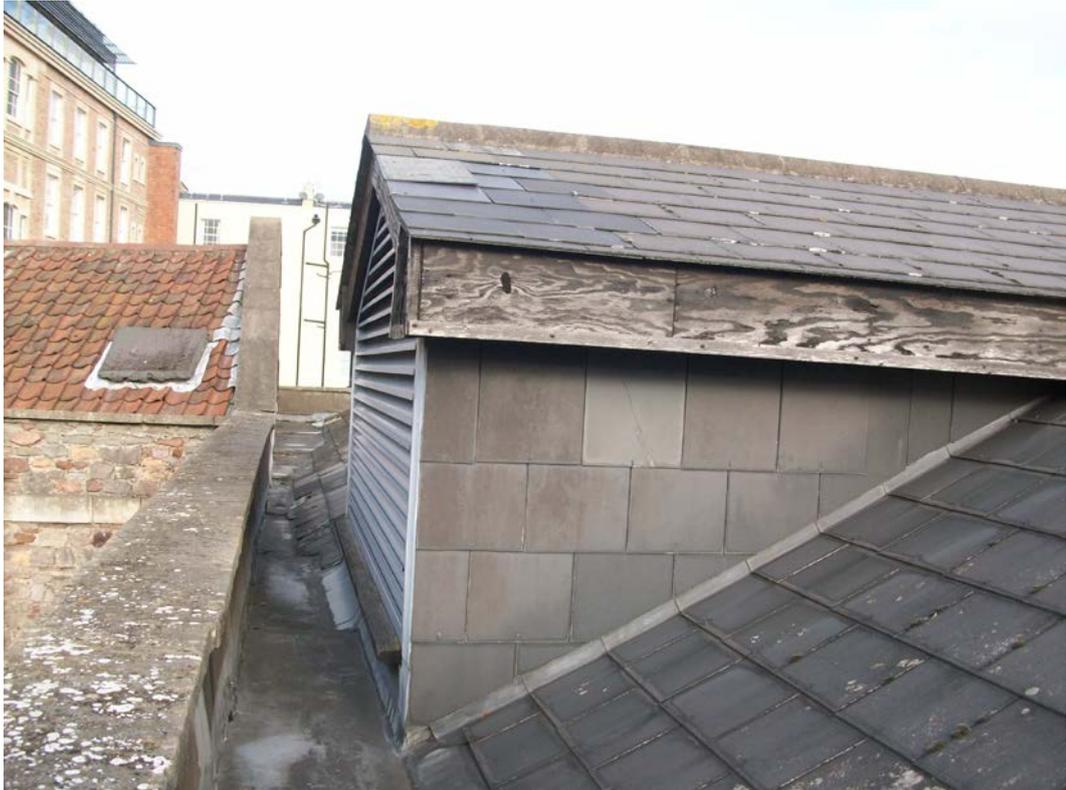
**Photograph 7:** Left hand (west) parapet, facing north. Timber fascia to dormer in poor condition.

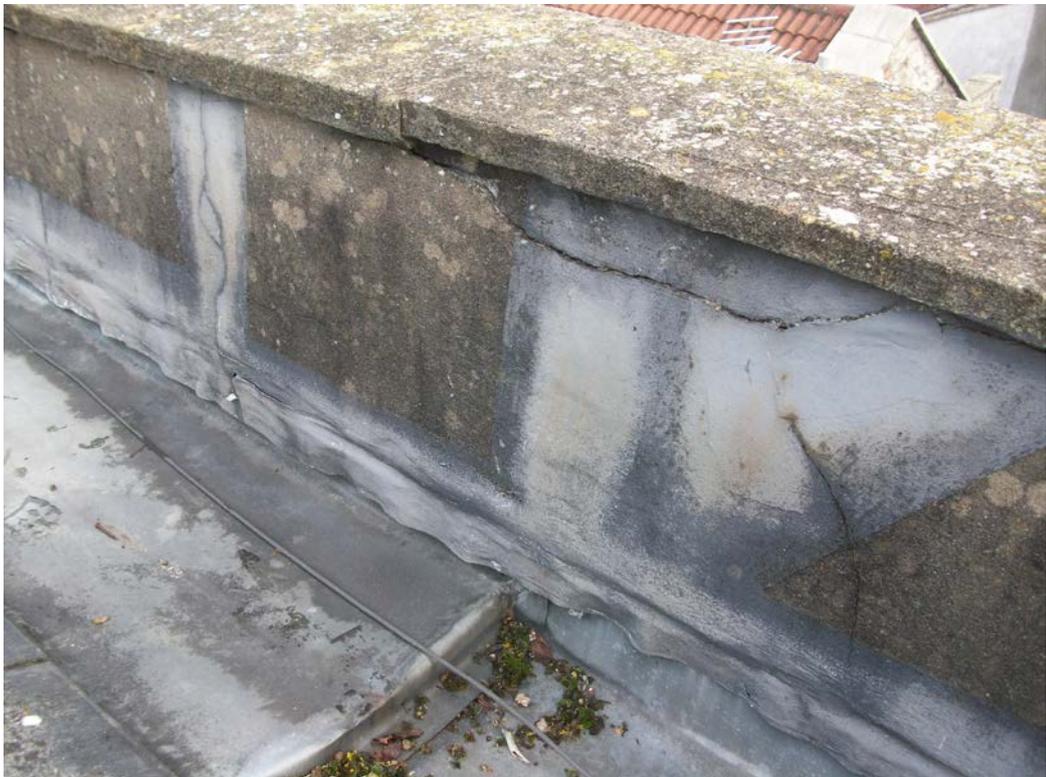
parapet has been rendered with a hard and inflexible cementitious render, which has cracked, and there has been ongoing water ingress into the property as a result. This has been exacerbated where the 4no. rainwater outlets to the parapet gutter are under-sized. The water ingress has caused minor damage to isolated areas of lath & plaster ceiling internally and caused decay to a section of timber wall plate. We estimate the roof was last re-covered approximately 30 years ago.

**Photograph 8:** Example of cracked and blown render to rear face of parapet.

- Renewal of the existing zinc parapet gutter linings with new (minimum) code 7 lead laid to equivalent design configuration as existing. This will be installed strictly in accordance with Lead Sheet Association guidance. Note the lead lining to the parapet is not visible from street level and is hidden from view by the stone parapets.
- The defective and unsuitable cementitious render to the rear face of the parapets will be carefully hacked off and renewed with a two coat lime based render (base coat 2:5 mix and finishing coat 1:3).
- The existing stone parapet copings will be lifted, a bitumenous DPM introduced and re-bedded using a 1:0.5:4.5 cement/lime/sand mortar mix.

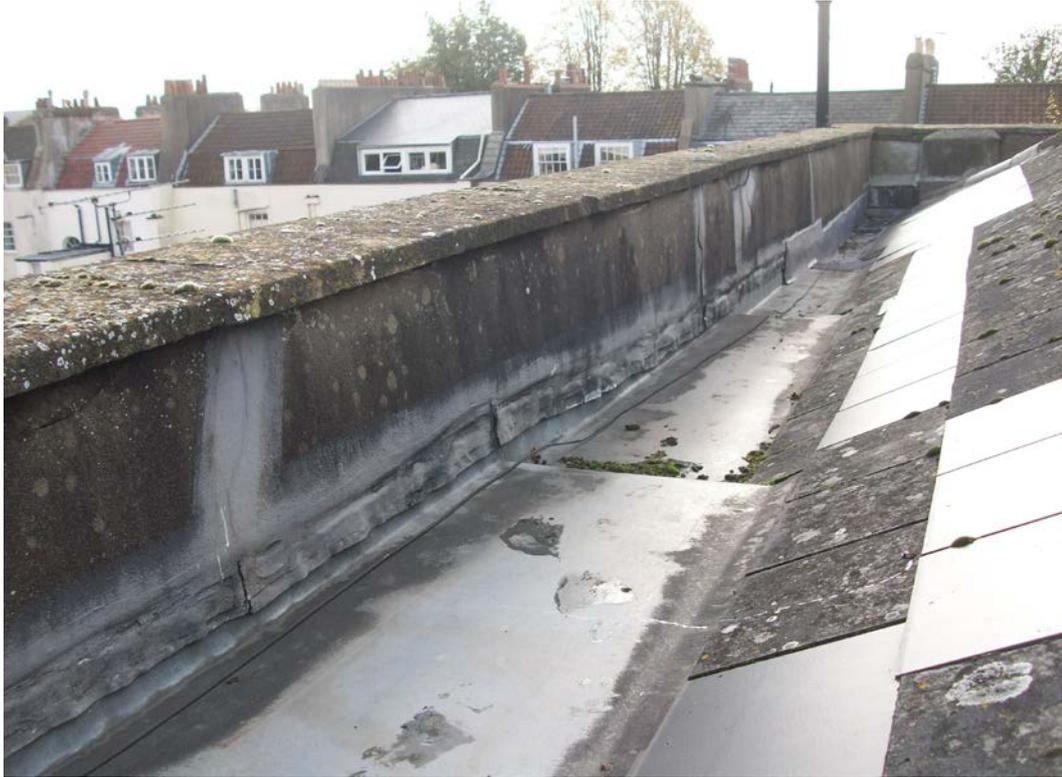
**Photograph 9:** Existing zinc gutter lining reaching lease end. Flashing upstands patch repaired.

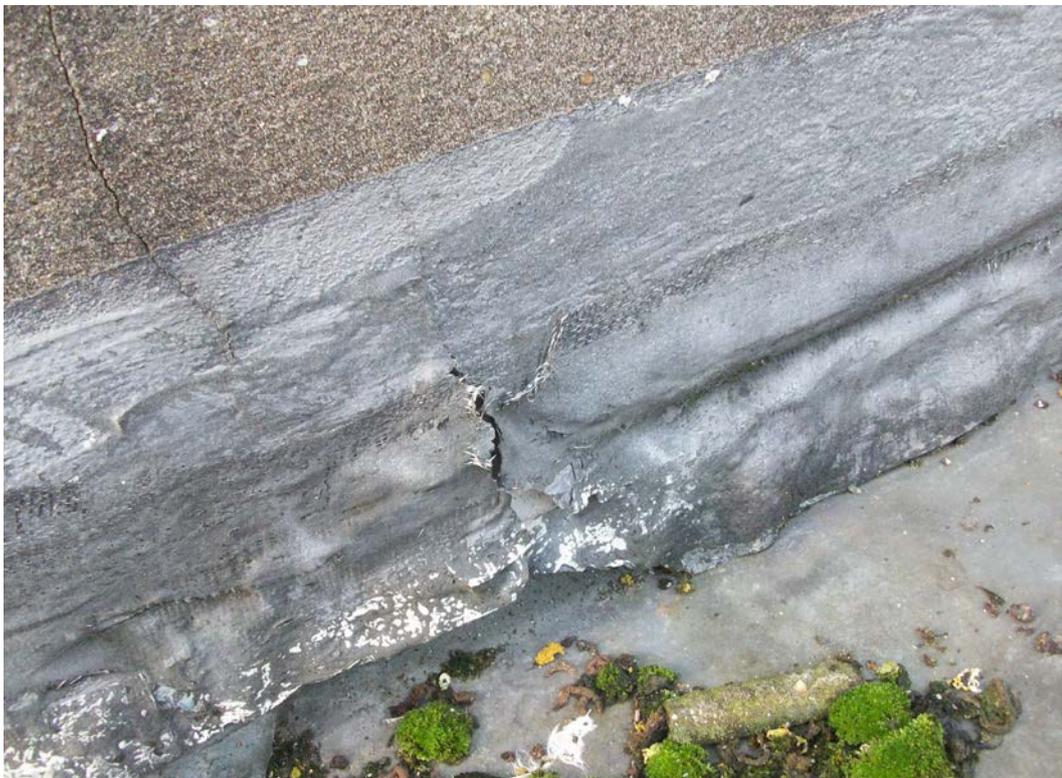
**Photograph 10:** Example of temporary repairs to gutter flashings.

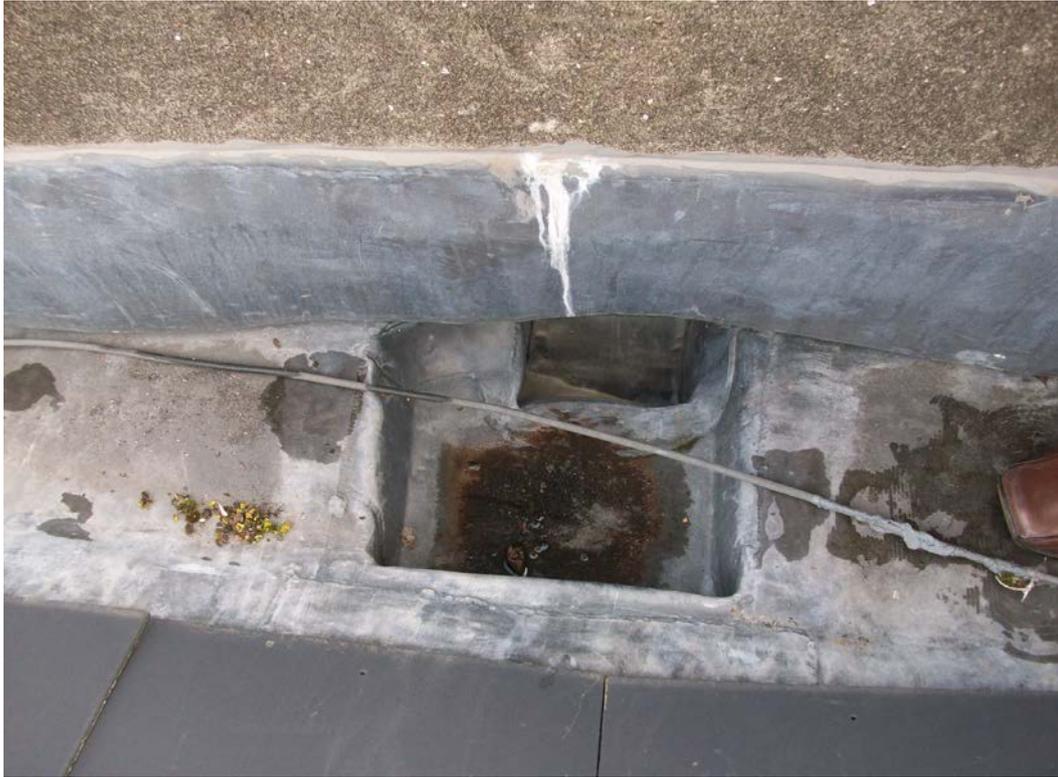
**Photograph 11:** Gutter outlets to be enlarged and re-lined.

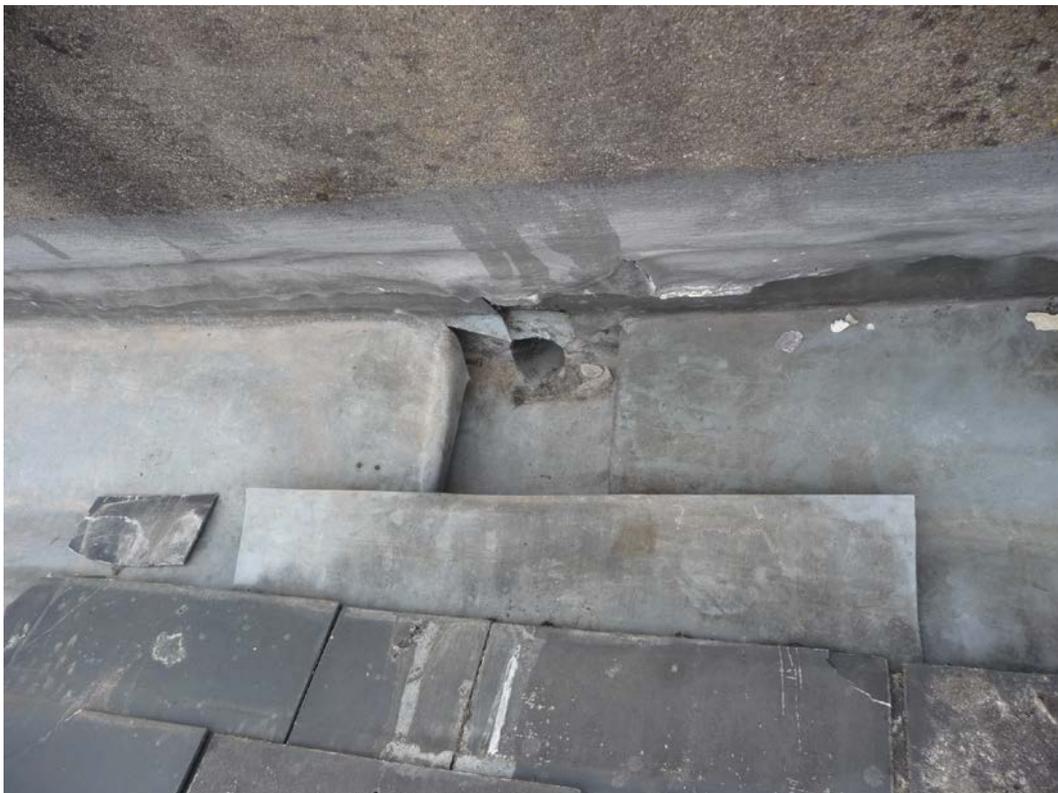
**Photograph 12:** Example of inadequate outlet to northern end of parapets.

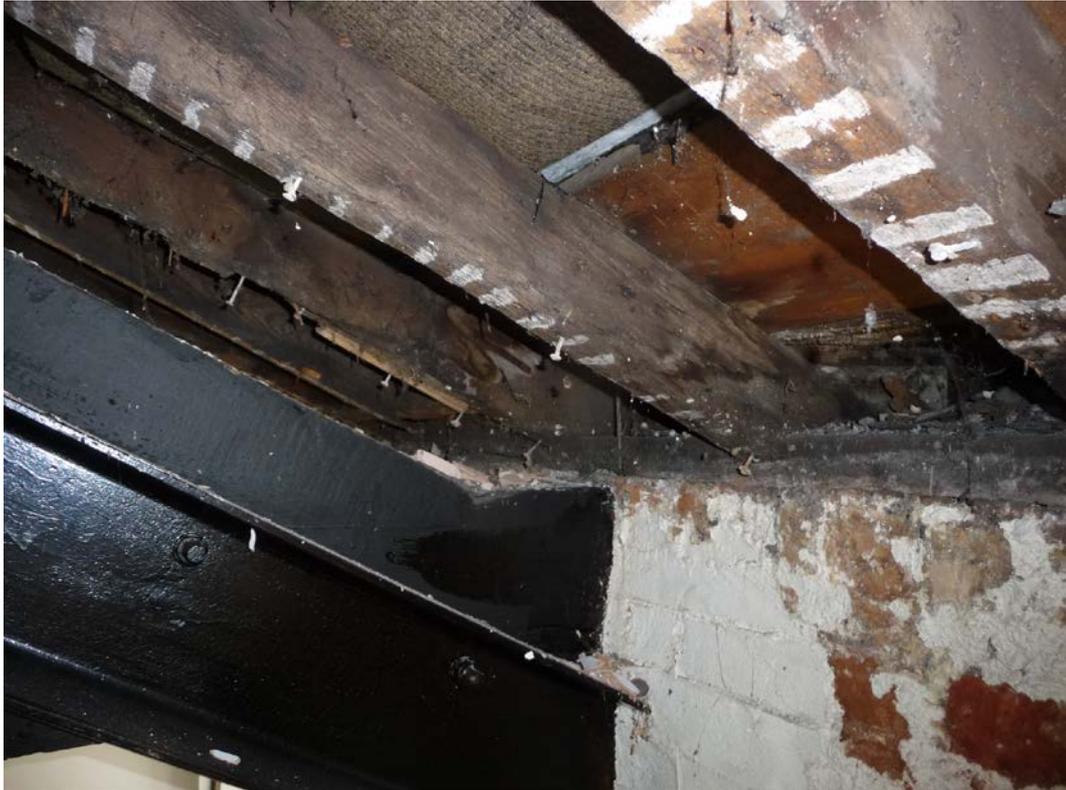
**Photograph 13:** Existing roof structure at eaves level. Damp affected ceiling removed.

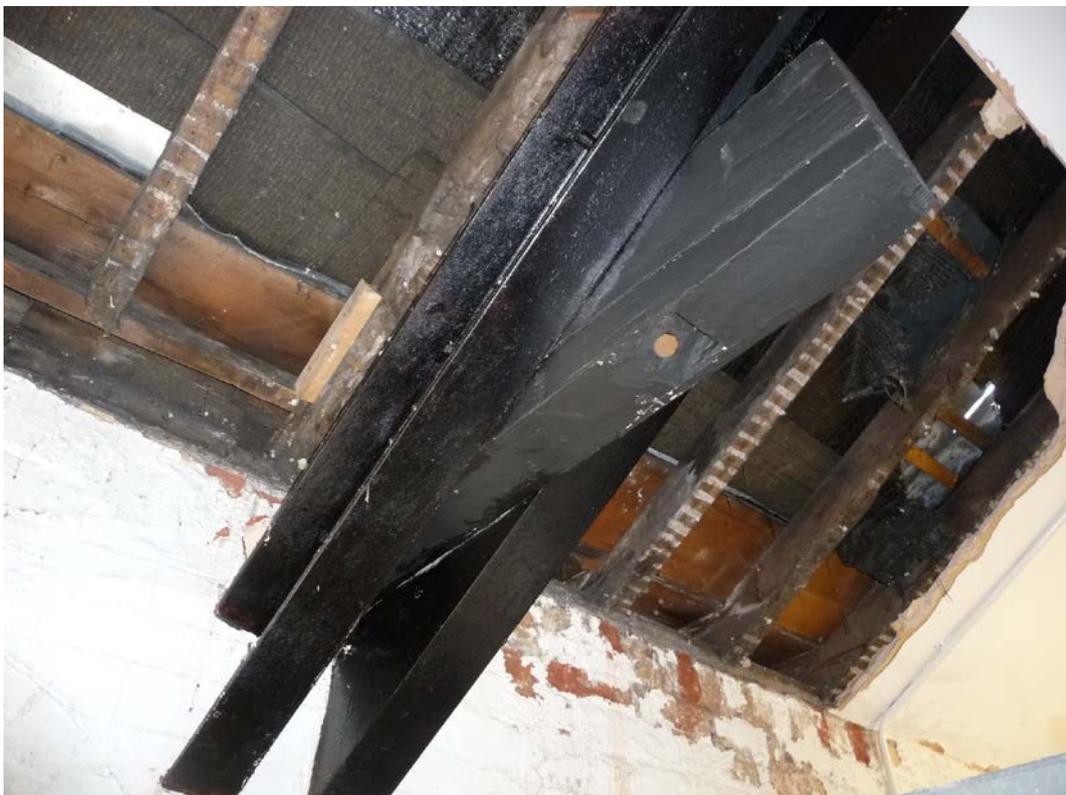
**Photograph 14:** Existing roof structure at eaves level. Existing structure to remain throughout.

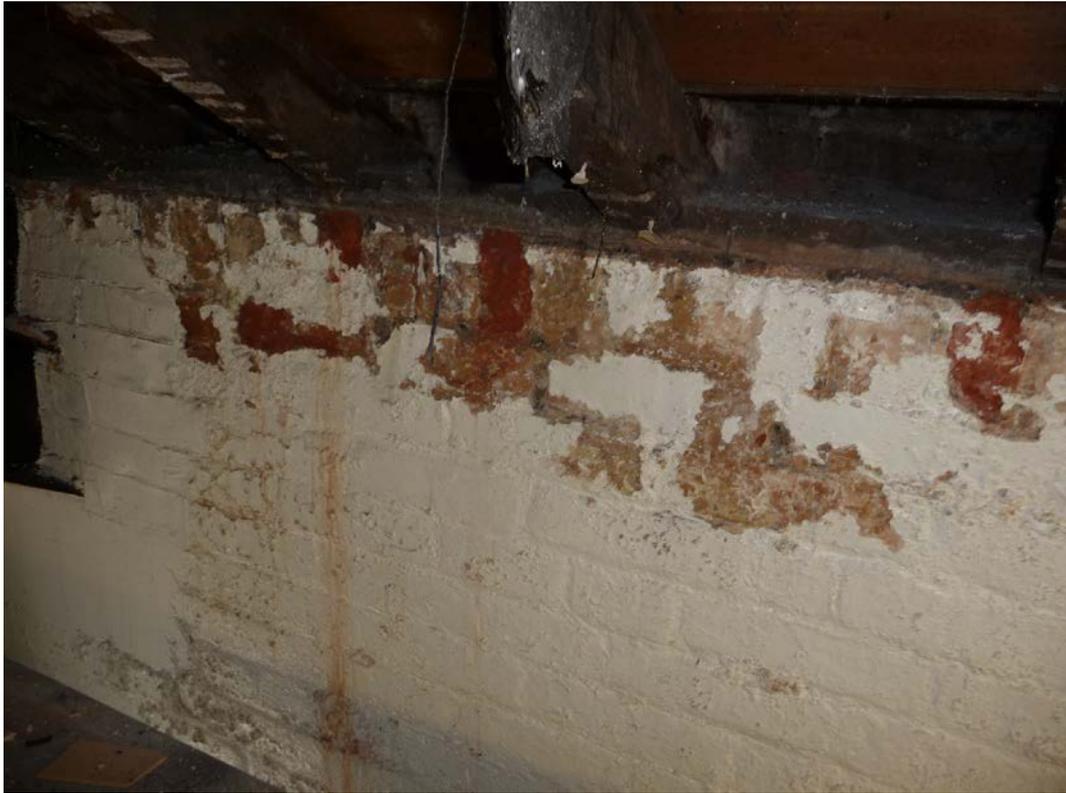
**Photograph 15:** Evidence of water ingress to inner face of brickwork.

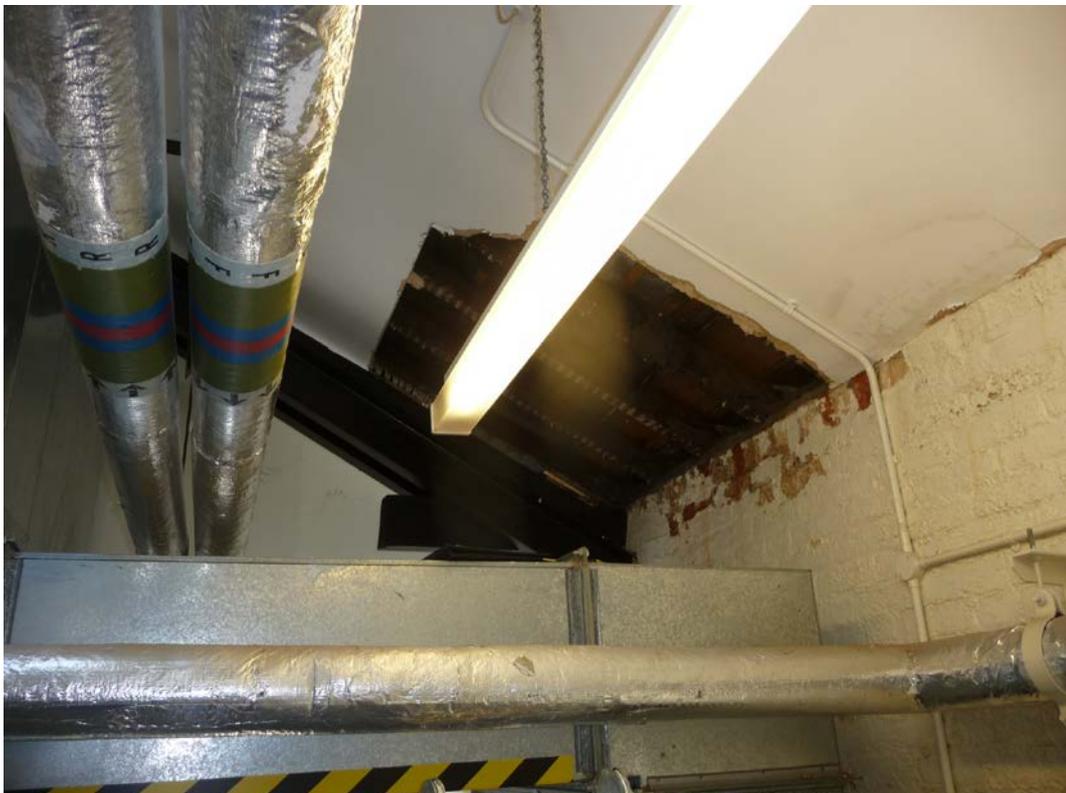
**Photograph 16:** Water damaged section ceiling above.

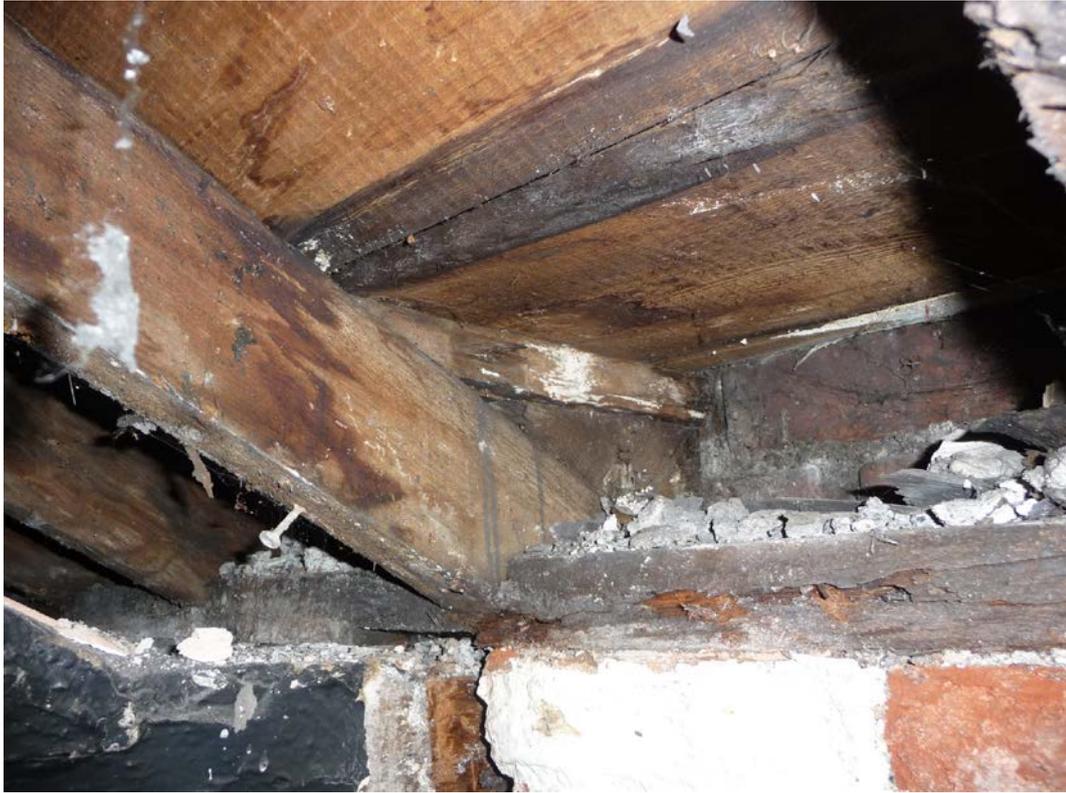
There has been water ingress into the building via the parapet gutters. This has damaged the timber wall plate. The works here will comprise:

**Photograph 17:** Rotten section of wall plate to the northern end of the right hand elevation.

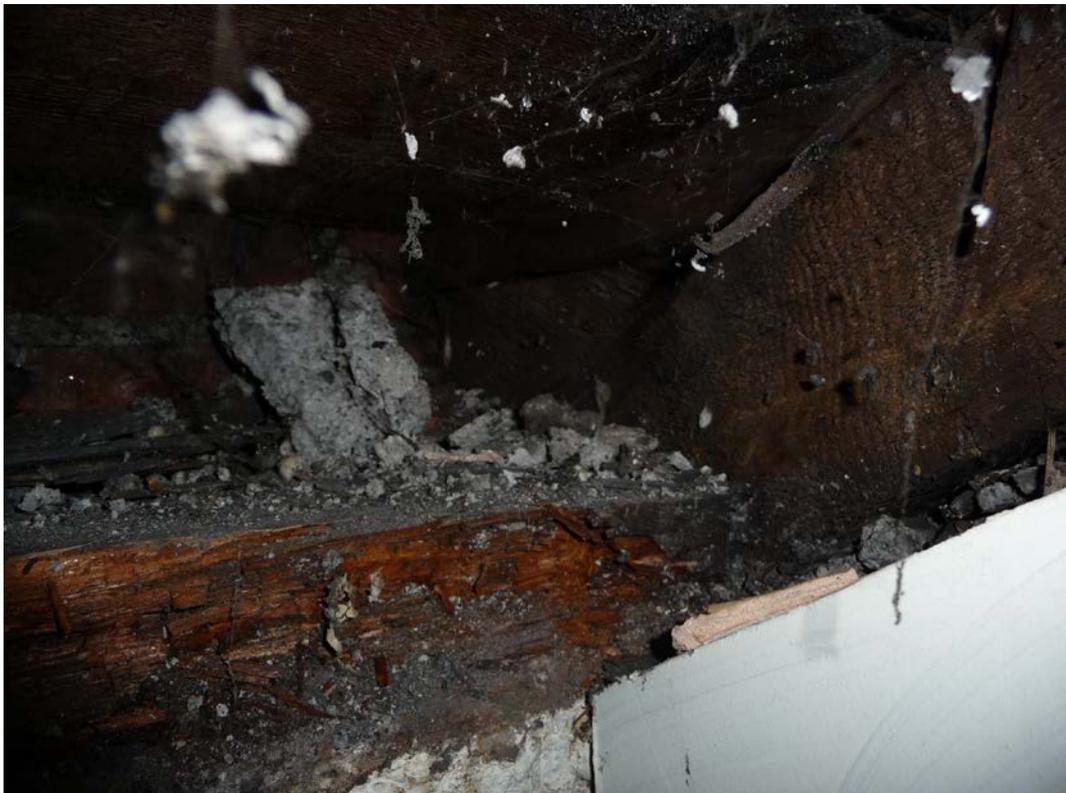
**Photograph 18:** Rotten section of wall plate adjacent to 10 Gloucester Street.

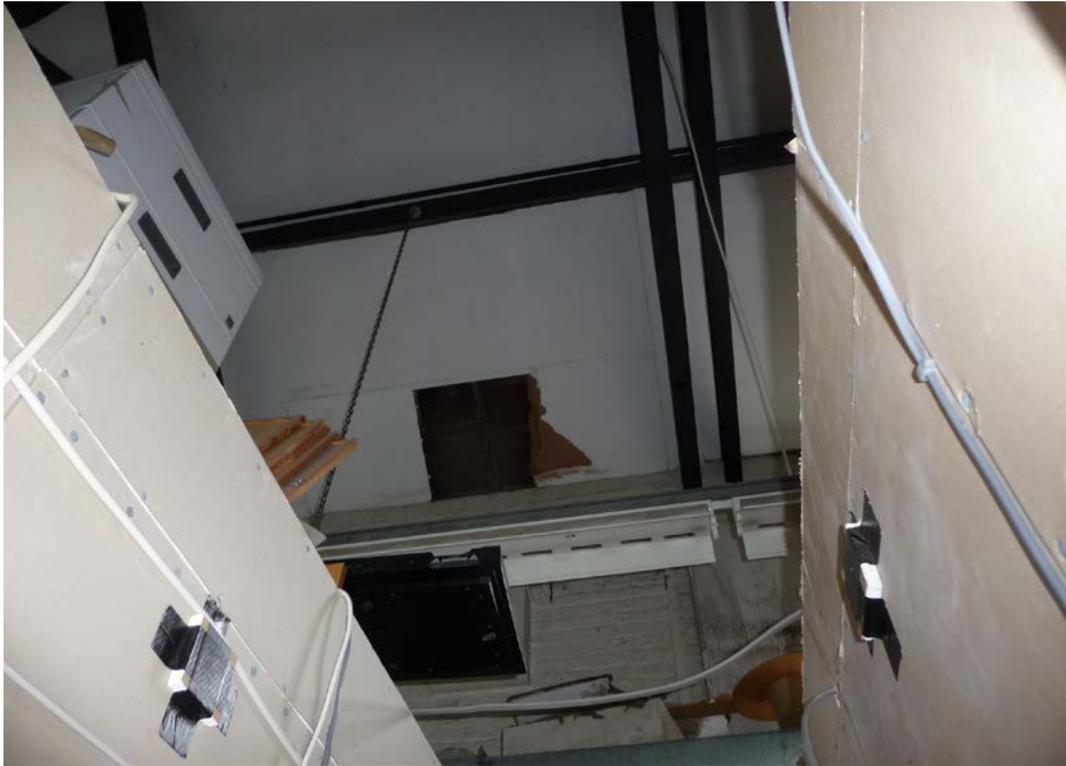
**Photograph 19:** Roof structure at mid-span. Original lath and plaster ceiling part replaced with plasterboard.

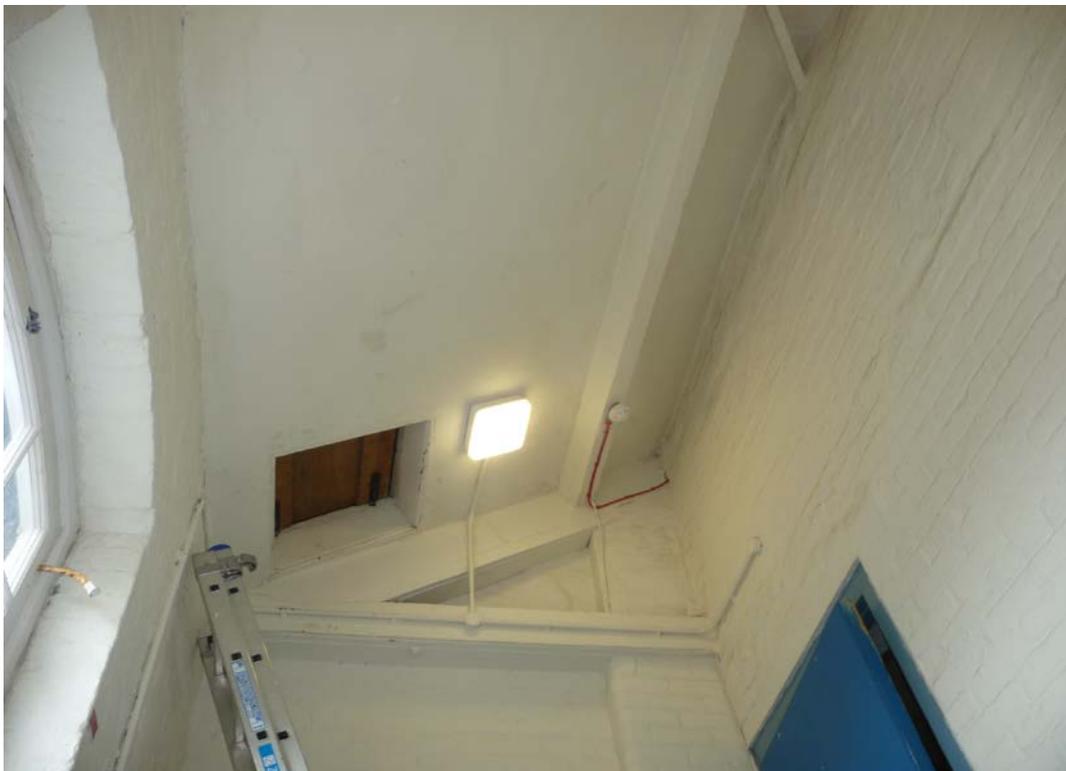
**Photograph 20:** Roof structure at SW corner of building and existing access hatch.
